PROBLEM SHOOTING FOR A LEAK

MACHINE REASSEMBLY

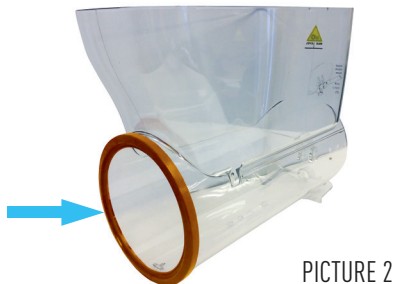
- 2** Place the large rubber seal (picture 1) on the back of the bowl then lubricate (picture 2).
