# PROBLEM SHOOTING FOR A LEAK

## MACHINE REASSEMBLY

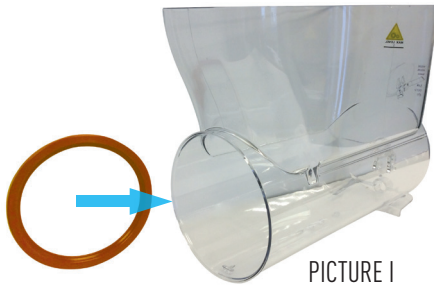
- 1** Lubricate the spinner seal with the grease. Place lubricated seal inside the spinner.

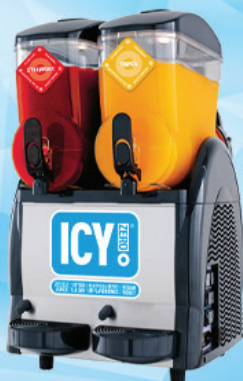
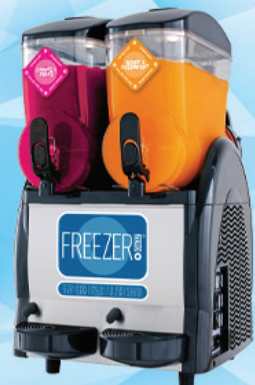
- 3** Replace the rubber bung in the tap and lubricate before inserting it onto the bowl.
